Postscript

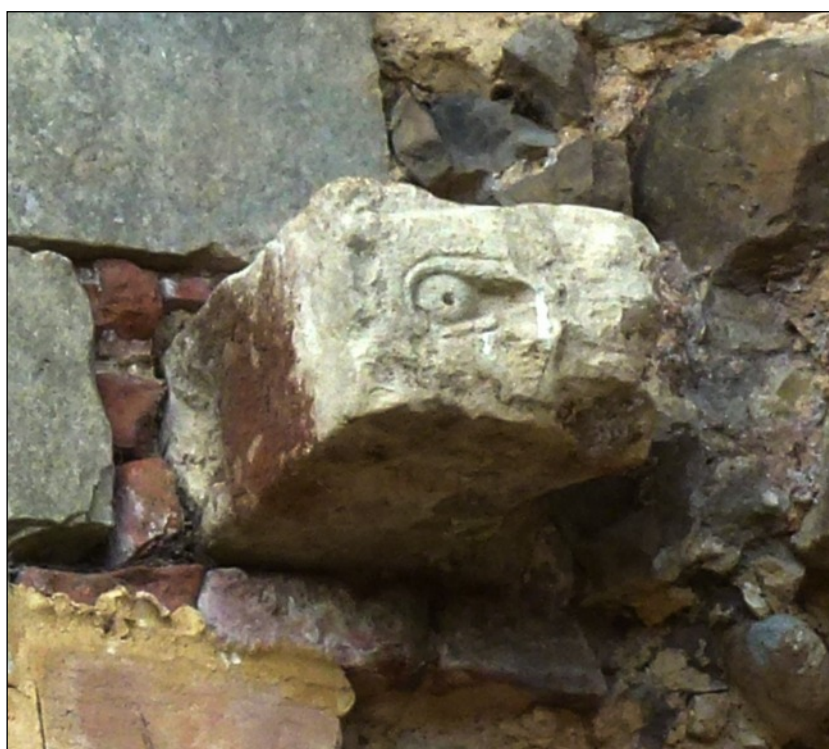
A single badly damaged carved block projects from the south-west angle of the former cloister. It is the remains of a finely carved gargoyle. An eyebrow and bulbous eyeball with a pierced pupil can be made out. Rainwater from the refectory would have drained through its mouth on to the cloister roof below. *(Photo: Valerie Fenwick)*
