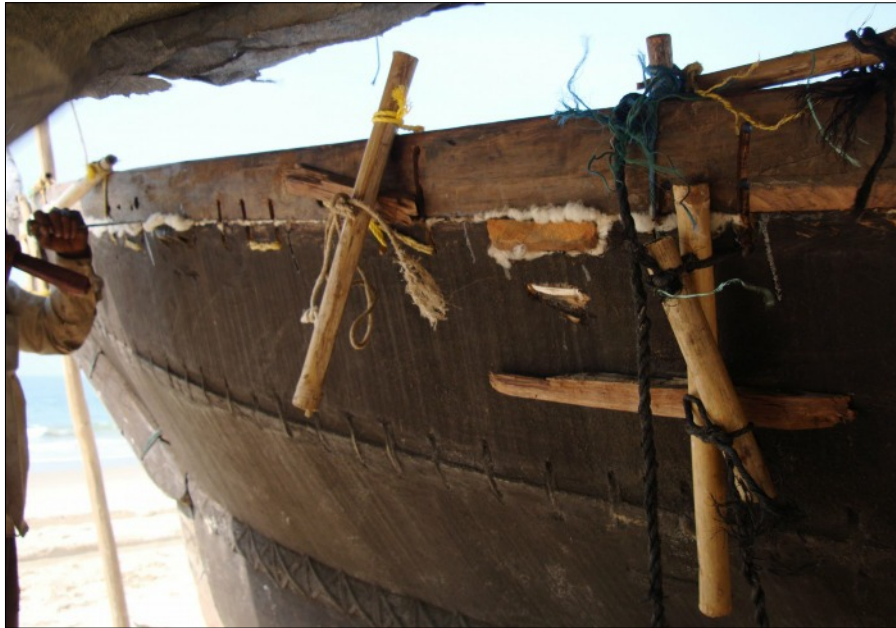
Figure 15 Despite use of scrap cords, close-set Spanish windlasses inboard and out exert pressure sufficient to bend a plank without steaming. Fish Road. Author.

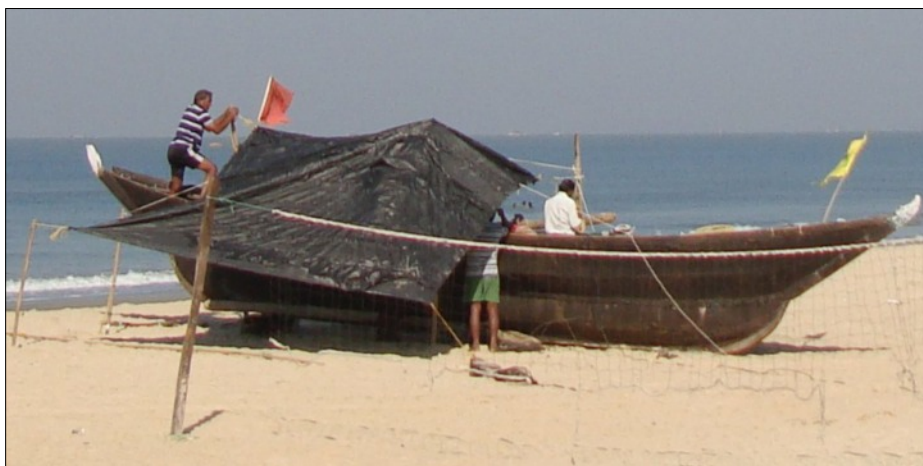
Figure 16 Damaged pirogue is traditionally beached bow-first. The crew erect a canopy to shade the boatbuilder. Fish Road. Author.
