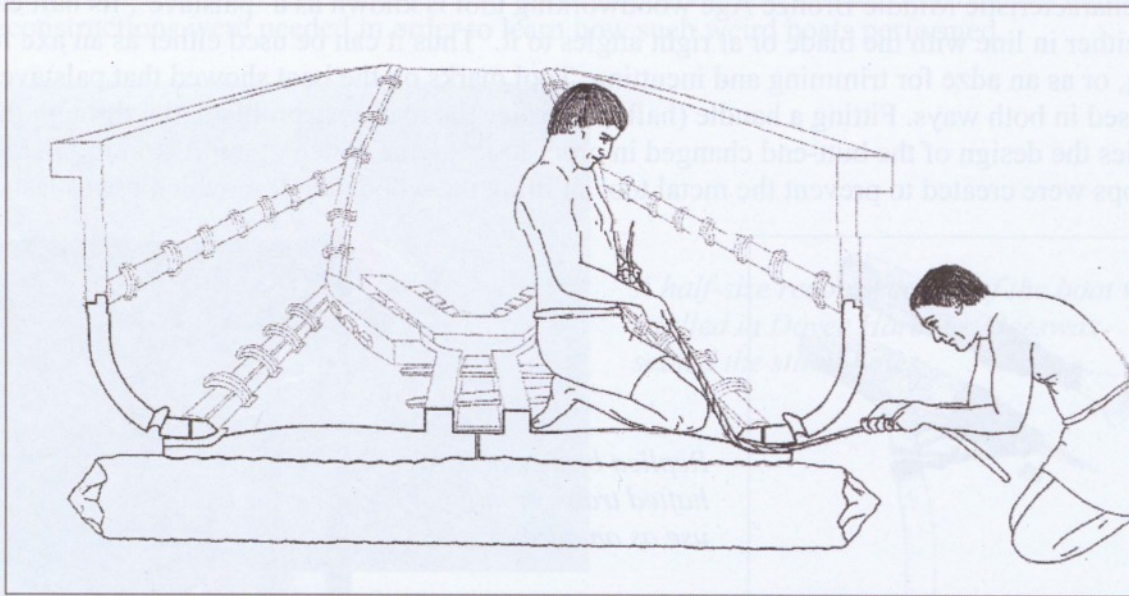
Different skills were required to stitch the planks together using twisted and cracked yew branches and applying tension. The seams were then covered with pads of moss covered with battens which further tensioned the stitches
