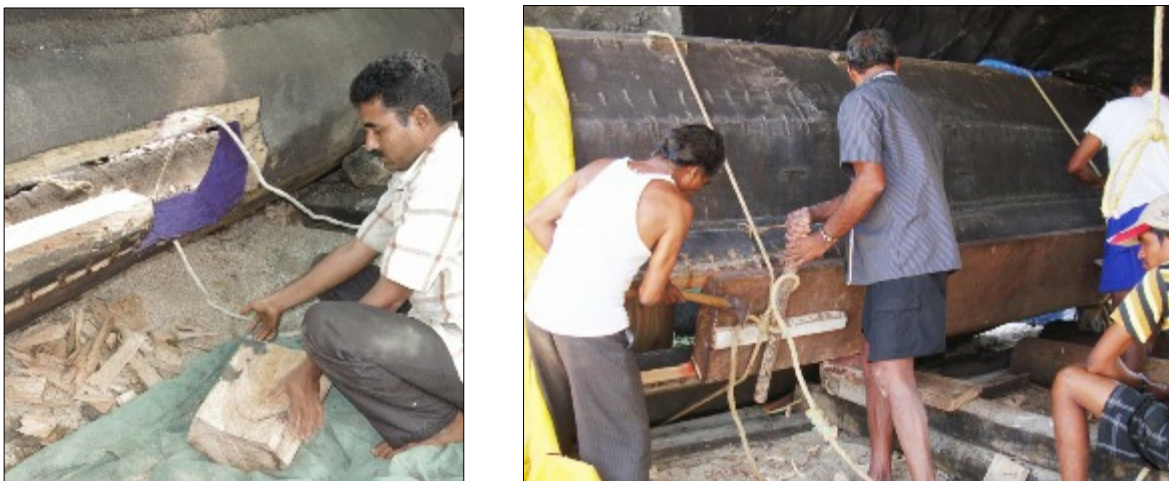
Figure 14 Repair to the underbody of a pirogue involves offering up new work numerous times: a) Siridau; b) Benaulim. Author.

even so have to be renewed fairly frequently. The faying surfaces of the basal log and of each strake need to be smoothed to an exact fit with a curved, finely sharpened blade and offered up numerous times, until, as an old boatbuilder indicated, not a hair of his head could be inserted (Fig. 14). Finally the lower surface is luted with diluted *chandrus* and whisks of cotton to impede its flow. Then the plank is positioned. It is compressed by the gradually applied pressure of numerous Spanish windlasses inboard and out, the cords of which pass through some of the holes pre- drilled for the stitching. With creaking noises the plank assumes the desired curvature (Fig. 15).
