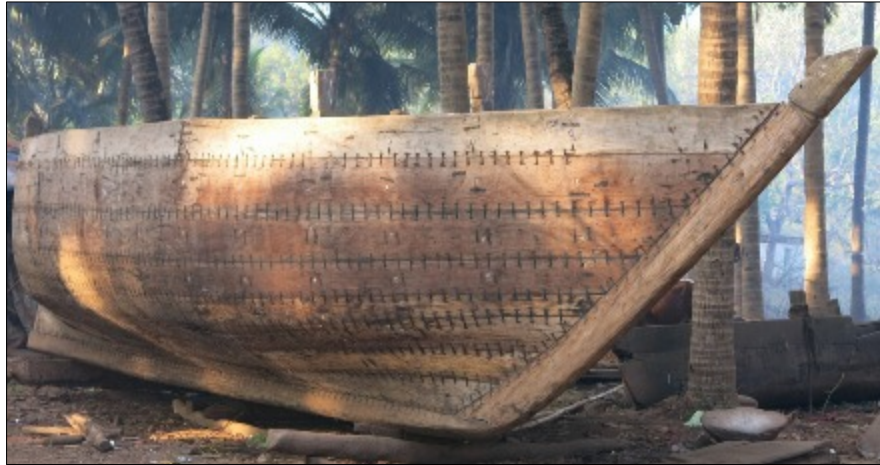
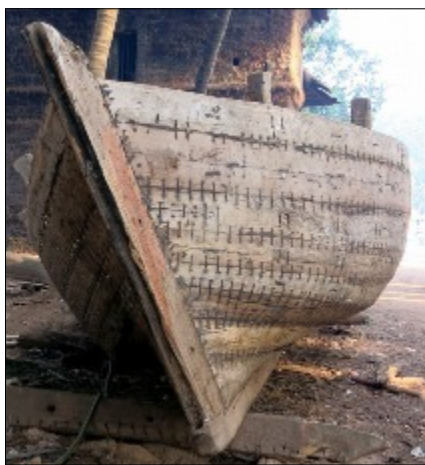
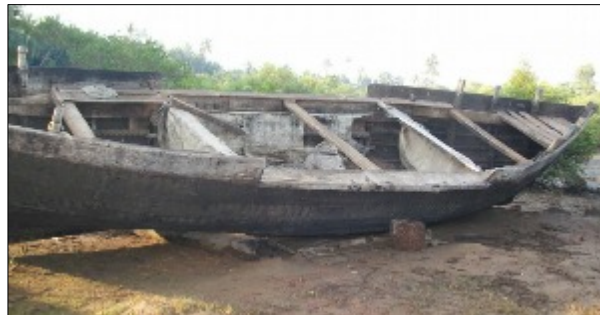
Figure 24. Sewn wooden dredgers used on Goa's rivers: a), b) 12m long under repair at Volvoi Ferry; c) beached near Keri. Author.

survived in a colonial backwater? Are they the descendants of the thousands of Indian coasters which continued to be built there after they had become obsolete elsewhere? Certainly sewn ships survived on the West Coast into the 20th century to be highly regarded by Hawkins for their qualities. As late as the 1970s he was able to see sewn dhows working along the Indian coast (1979:105,132). It may be that the last example of indigenous sewn-plank construction is represented by these humble, now threatened, dredging vessels.
