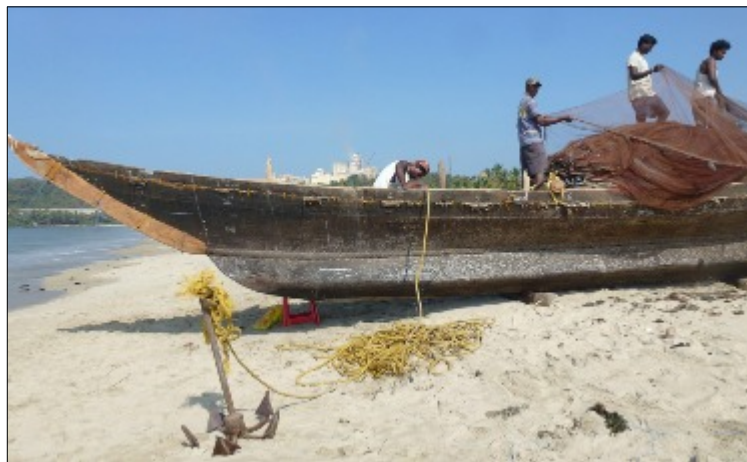
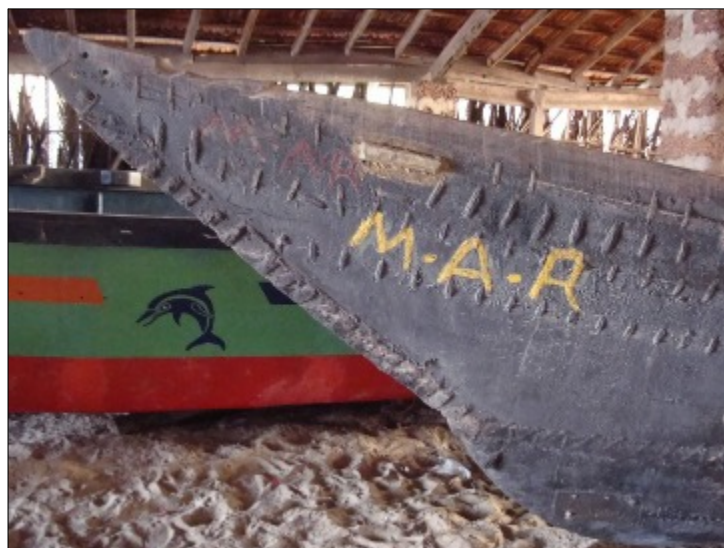
Figure 7. a) new stem-cap with only five stitches securing it. Velsao Danddo;
b) old stem minus its stem-cap, revealing closely oversewn hood-ends. Sernabatim.
Author.

Four are now commonly found. Fore and aft the hood-ends of the strakes are merely sewn to each other in a construction lacking either stem or sternpost. Instead the seam at each end is covered and protected outboard by a carved v-sectioned cap secured with only a few widely spaced stitches (Fig. 7). The weak attachment reflects the necessarily sacrificial purpose of the caps since, during launching and beaching, the craft's overhanging extremities are liable to impact in the surf, and are frequently damaged.
